DAM SAFETY UPGRADE OF THE RUSKIN DAM RIGHT ABUTMENT

Nathan Sweeney, P. Eng., Senior Engineer, Generation Engineering, BC Hydro, Burnaby, BC, Canada
Li Yan, P. Eng., Engineering Team Lead, Generation Engineering, BC Hydro, Burnaby, BC, Canada

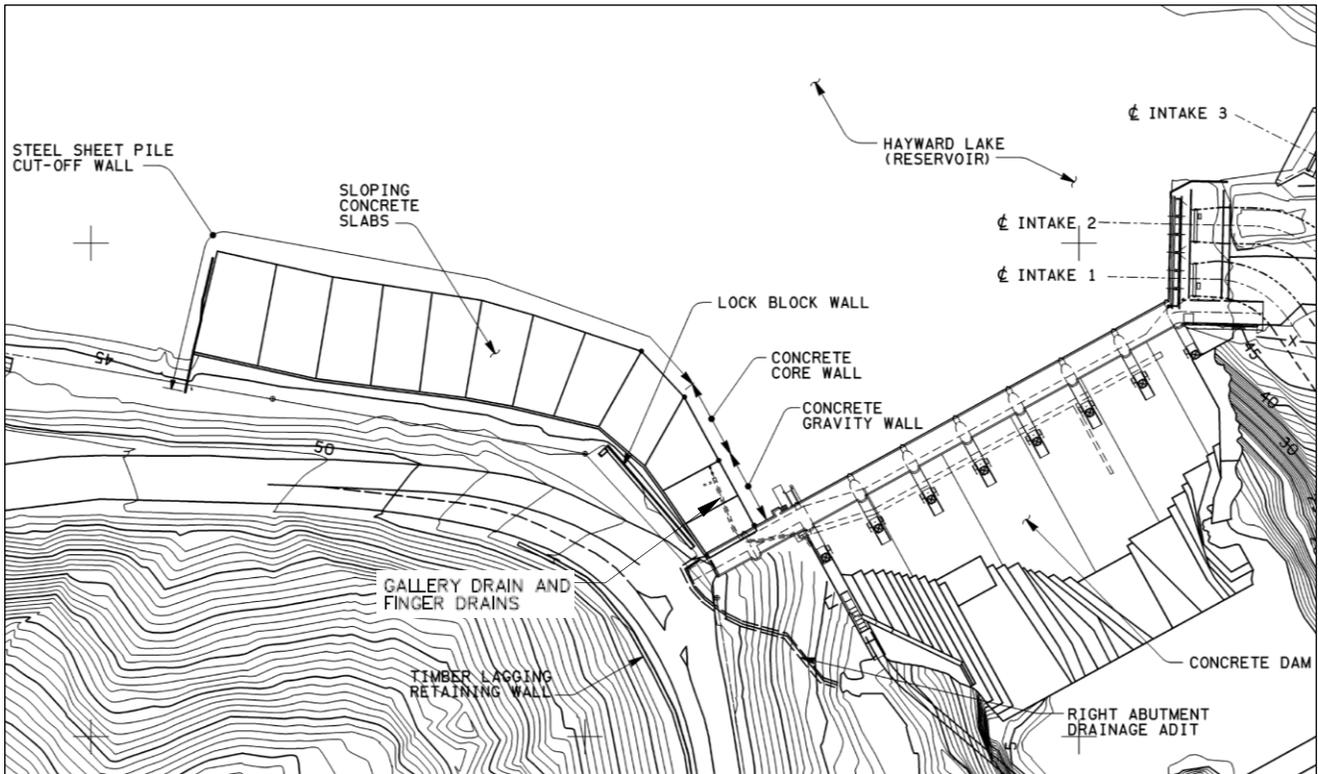
Performance issues occurred immediately in the right abutment during first filling of the reservoir in 1930, when sand-laden seepage flows began flowing from the finger drains into the gallery drain and exiting into the spillway (see Figure 3). Flows through the gallery drain reached a maximum of 566 l/min, and about 68 m³ of sand was measured over a period of 5 months, once the reservoir elevation had reached El. 42.6 m (near the normal maximum level). The constant loss of sand through the rockfill resulted in settlement of the concrete slabs in 1931, and an inclined shaft was constructed to inspect the underside of the slab. Cavities were backfilled with coarse gravel and grout was injected via pipes installed through holes in the face of the slabs in an attempt

to seal the voids in the rockfill. A number of remedial measures were attempted to stop the piping, including driving additional sheet piles and the placement of clay at the upstream end of the slabs, plugging the finger drains with sand and clay, and dumping clay at the joint between the gravity wall and core wall. In 1932, a 1.1 m wide by 1.5 m high adit was constructed to provide an alternate drainage path to the finger drains (see Figure 3). The concrete-lined-adit was connected to the rockfill via a gravel filled screen, which ensured that the rockfill remained dry above about El. 30 to 32 m. Flows were measured at the downstream end of the adit, and voids continued to be monitored beneath the slabs by soundings through the grout holes. Ground settlement and sinkholes continued to occur on the bank above the top of the concrete slabs.

Figure 3: General arrangement of Ruskin Dam and right abutment – prior to upgrades

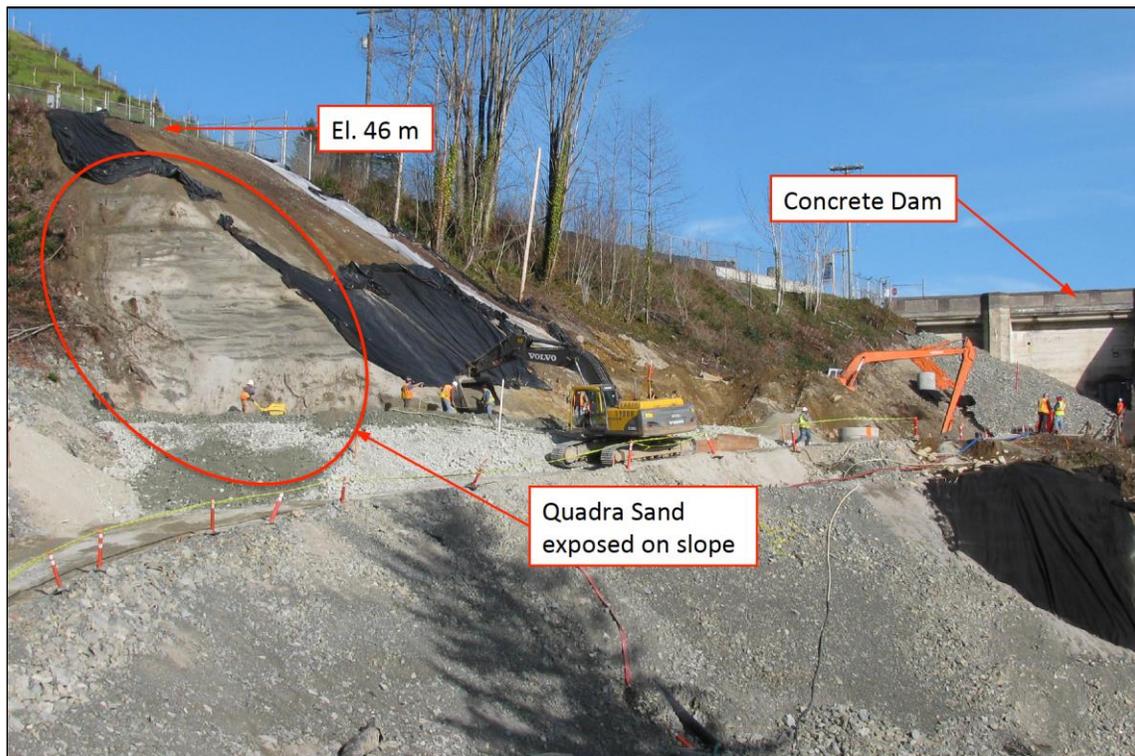
Most of the dam safety issues at the right abutment are related to the presence of Quadra Sand (Unit 4). The sands, although dense, are highly susceptible to the seepage-caused migration of fine material, which can result in the formation of pipes and sinkholes or other forms of localized loosening. Quadra Sand is present on both the right and left abutments, but is most prevalent on the right abutment, where it ranges in thickness from about 15 to 20 m below the top of the dam (see Figure 6). The sand is also located on the hill above the dam with a variable thickness of up to about 20 m.

Figure 6: Exposure of Quadra Sand on the right abutment downstream of the dam

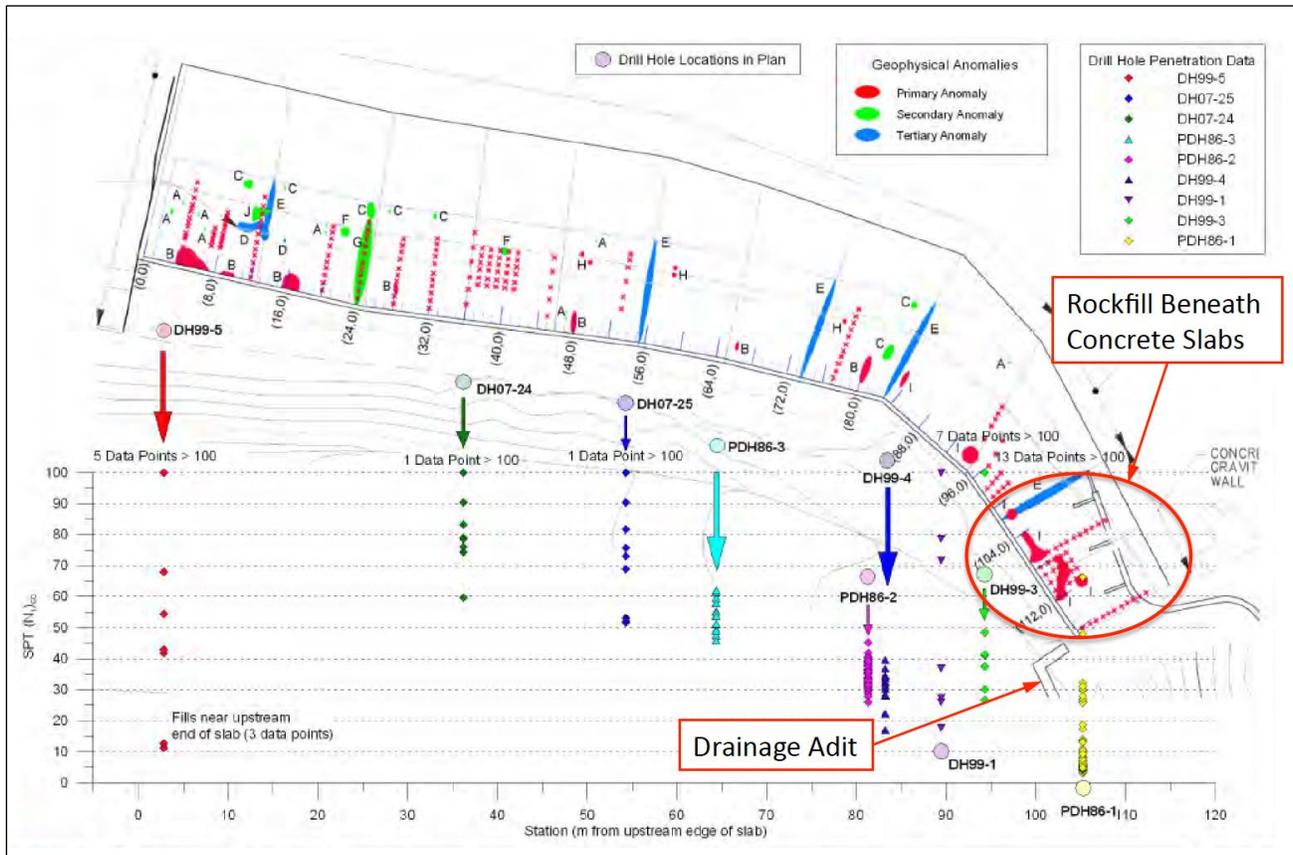
These data were combined with the results from cross-hole geophysical testing and penetration data to determine areas of loosened sand. Figure 7 shows penetration data plotted by station from the upstream end of the slab and the locations of primary, secondary and tertiary anomalies from the results of the non-intrusive geophysical investigations. The results indicate that large voids are not likely to exist beneath the concrete slabs, but suggest that localized zones of disturbed sands are present, which appear to correlate with the locations of sinkholes and depressions, geophysical anomalies, variations in measured shear wave velocities and reduced in situ densities. In order to evaluate the in situ soil density of the disturbed sands, a 20 m deep CPT was conducted under the slabs near the rockfill, at an inclination angle of 70°. The results of this test indicated that the disturbed sands have a measured cone tip resistance (q_t) of 18 to 21 MPa, from which an equivalent $(N_1)_{60}$ of about 34 blows/ft was derived.

- Near the upstream end of the concrete slabs (disturbance in this area may have been caused by seepage around the end of the cut-off or reverse gradients during reservoir drawdowns).
- In the area around the rockfill (likely caused by piping of fines or sand into the rockfill).
- In the area around the adit (possibly caused by seepage flowing along the back or sides of the adit). The extent of this loosened zone appears to be limited to less than about 5 m from the adit.

Figure 7: Location of potential voids and loosened soil

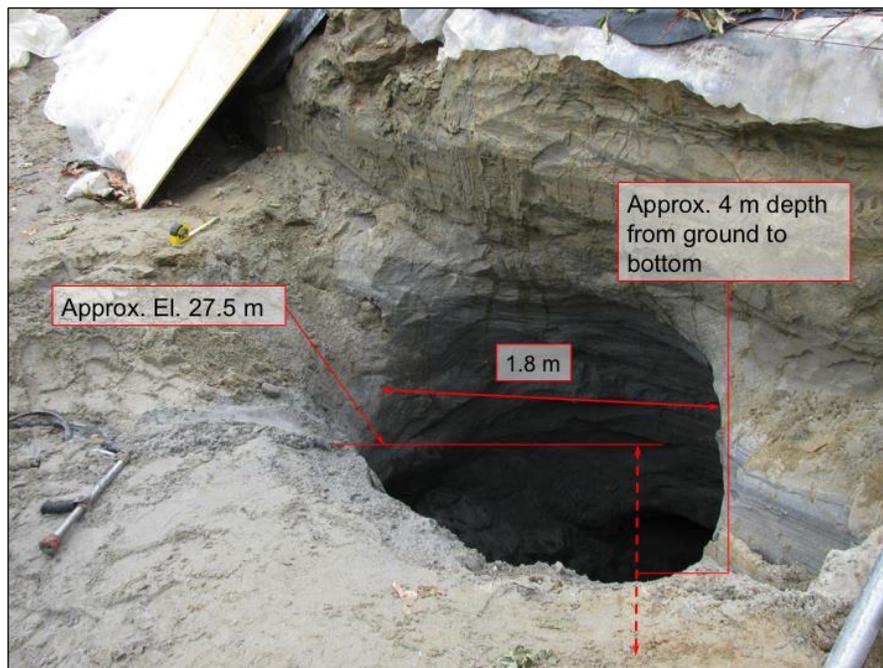
In addition to these locations, several very large features have been found downstream of the dam, which may be related to subterranean seepage flows in the sands. A buried sinkhole discovered in this area in 2009 was measured to be about 1.8 m in diameter and about 4 m in depth from the top of the exposure (see Figure 8). No significant seepage was noted to be present in the sinkhole. In 2012, another large void was encountered near the same area during sonic drilling and cone penetration testing. These sinkholes are believed to be associated

mainly with seepage from the hillside, not the reservoir, but highlight the propensity of the Quadra Sand to become loosened through seepage and fines migration.

Figure 8: Sinkhole discovered in the Quadra Sand unit downstream of Ruskin Dam

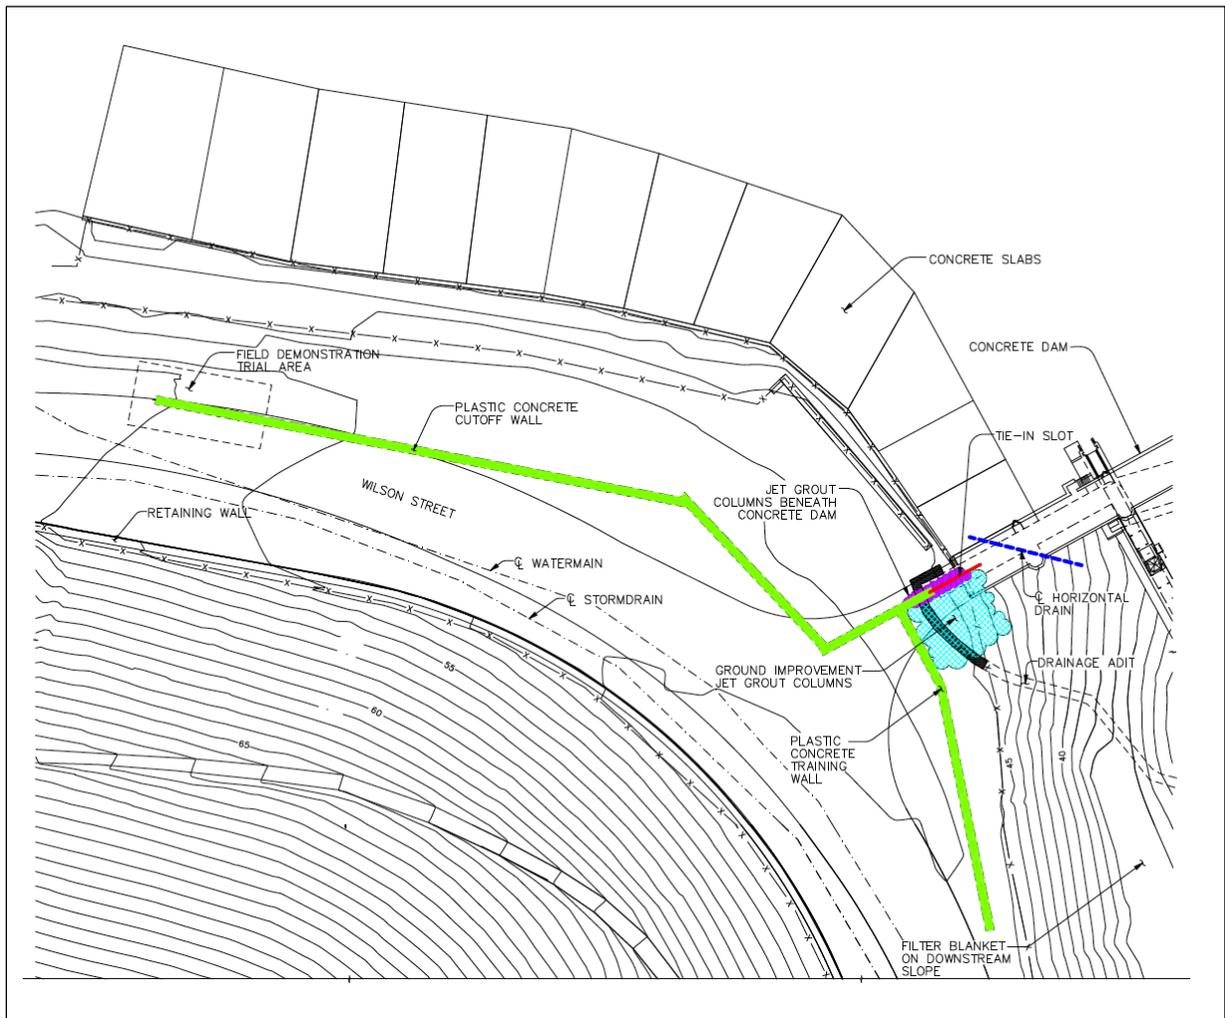
Figure 10: General arrangement of right abutment upgrades

- A new cut-off wall located inland from the top of the existing concrete slab cut-off wall. Deformations at the wall are minimized by placing it a sufficient distance away from the sloping concrete slabs and potentially loosened soils.

- Jet grouting adjacent to and below the right abutment end of the concrete dam and around the drainage adit to strengthen the soil and allow for the construction of the slot for the tie-in of the new cut-off wall with the concrete dam.

- Tie-in connecting the cut-off wall with the concrete dam constructed with overlapping drill holes and backfilled with a highly flexible, watertight material. The flexible tie-in is required to be highly robust, capable of surviving the differential deformations between the dam and right abutment soils expected during the MDE.

- Jet grouting of the soil immediately downstream of the tie-in to strengthen any potentially disturbed soils and loose fill, and thus minimizing seismic deformations. The improved soil also provides support for the new two-lane bridge above the dam.

- A seepage training wall to direct seepage away from the loose fills downstream of the dam and into a downstream filter blanket.
- A reverse filter blanket, sheet pile erosion barrier and drainage system on the downstream slope to prevent piping and collect seepage.

- A horizontal drain to replace the drainage adit and maintain the groundwater between the two cut-off walls near the existing level, preventing failure of the slabs during reservoir drawdowns.

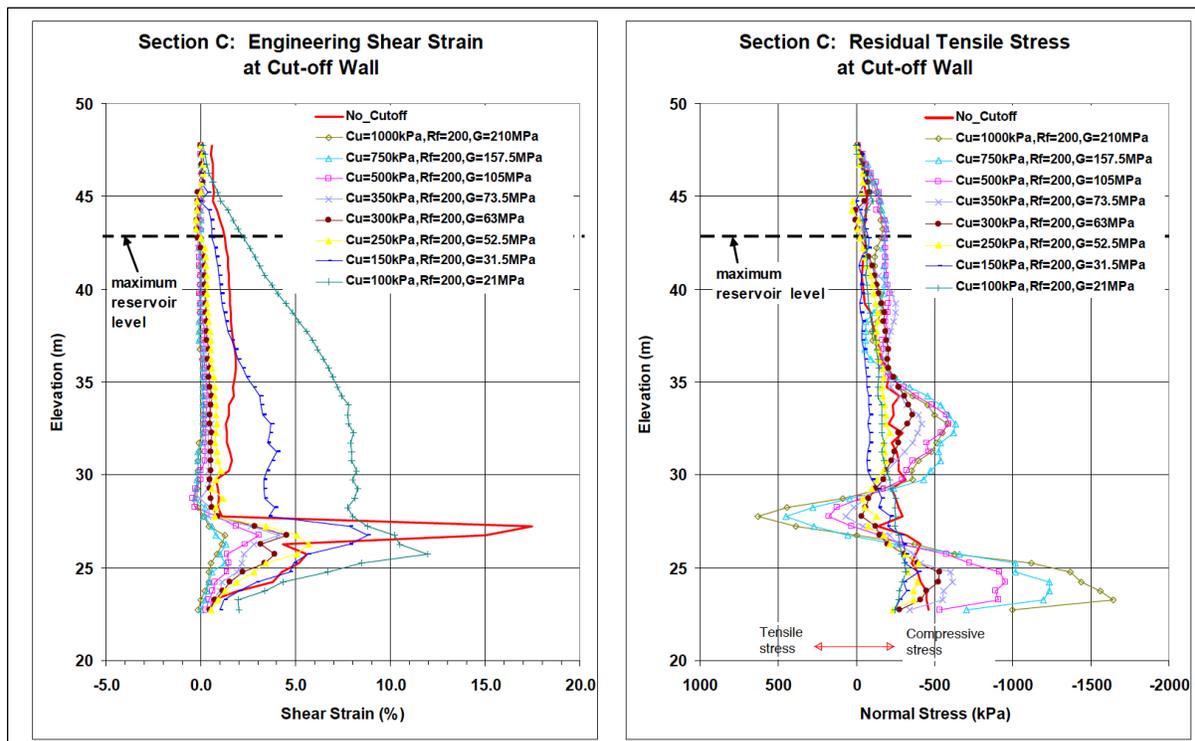
Non-linear seismic deformation analyses were carried out during the design phase with the finite element program VERSAT (Wu, 2009) to calculate probable deformations and strains, and to model the stiffness of the plastic concrete material. The performance of the cut-off wall and training wall was analyzed for both the MDE and the 1 in 475-year earthquake. Eight time histories were used, which were linearly scaled to the uniform hazard response spectrum at the period of interest. For the cut-off wall, the average displacements calculated for the MDE at the maximum reservoir level (El. 42.9 m) were generally less than 350 mm and the computed strains were generally lower than the 15% shear strain (10% axial strain) limit of the plastic concrete. Parametric analyses were also conducted to investigate the impact of the wall stiffness on the stresses and deformations. The shear strength of the wall was varied between 0.1 MPa to 1 MPa and subjected to the MDE ground motions. Generally, large strains were computed in the wall for the low strength plastic concrete, and higher tensile stresses developed when the plastic concrete was assigned higher shear strengths, especially at the elevation of the Unit 3 silt. Based on these results, an envelope of shear strengths between 0.1 MPa and 0.75 MPa, approximately corresponding to unconfined compressive strength (UCS) values of 200 kPa and 1.5 MPa, were used for the plastic concrete. Example strain and tensile stress results from a typical deformation analysis at the

cut-off wall are shown in Figure 11. The analysis also indicated that cracking is not likely to occur for the 1 in 475-year earthquake ground motions.

Figure 11: Earthquake-induced strains and tensile stresses at cut-off wall

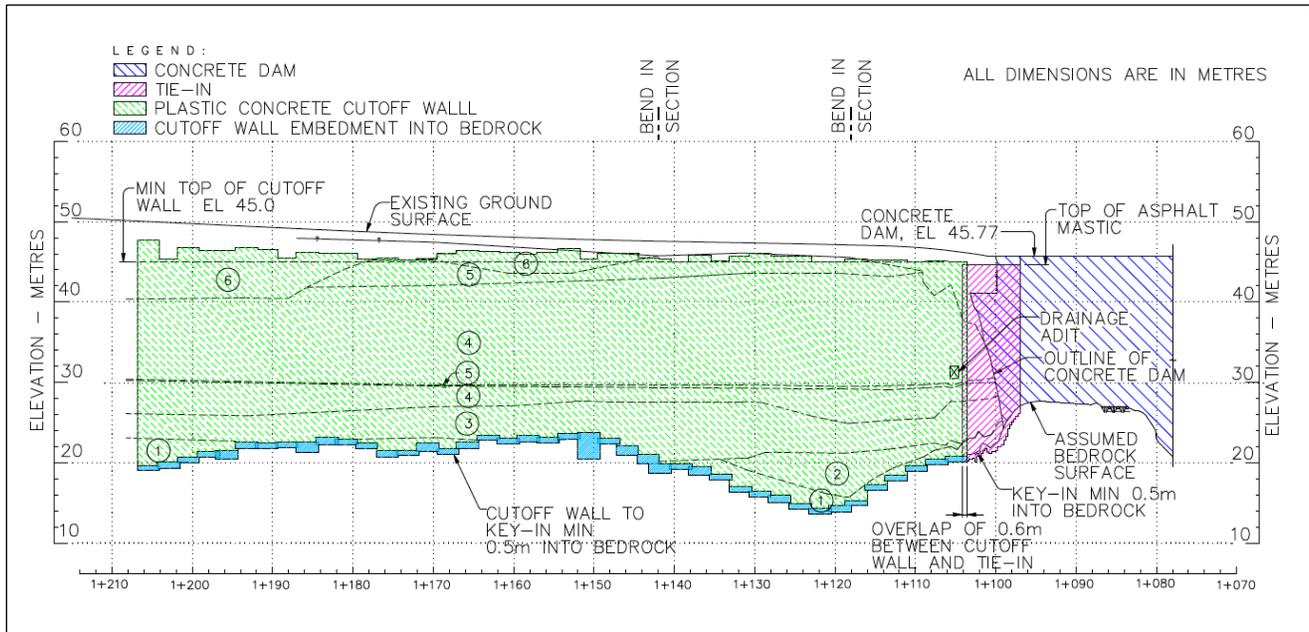
Figure 12: Section through cut-off wall and tie-in

As part of the design for the tie-in, the soils beneath the overhanging portion of the concrete dam were jet grouted to create a block of soilcrete with a minimum UCS of 6 MPa, and the first panel of the plastic concrete wall was excavated into the soilcrete to form a key. A slot was then constructed by a series of overlapping drill holes in the dam, soilcrete, and plastic concrete, and extended a minimum of 0.5 m into bedrock. To construct the slot, very accurate NQ primary pilot holes were initially drilled along the slot length. These holes were then opened to 0.3 m diameter and a special guide system was used to drill the 0.3 m diameter secondary holes by following the primary holes on either side, resulting in a slot with a minimum width of 168 mm. The slot was

backfilled with highly flexible asphalt-based mastic capable of withstanding 50 mm of concentrated deformation. To ensure that the end of the tie-in does not crack during a seismic event, the slot was extended past the soil/bedrock/concrete interface by about 2 m and into the gravity portion of the dam. A section through the tie-in is shown on the right side of Figure 12. Downstream of the dam, the loose fill soils were strengthened by jet grouting to provide additional stability for the tie-in during a seismic event while also acting as the foundation for the downstream footing for the new bridge deck. The jet grouted block extends approximately 8.5 m downstream of the dam centreline and about 10 m east from the training wall (see Figure 10). The vertical extents are from El. 43.5 m to bedrock or the Unit1/2 soils located immediately above bedrock.

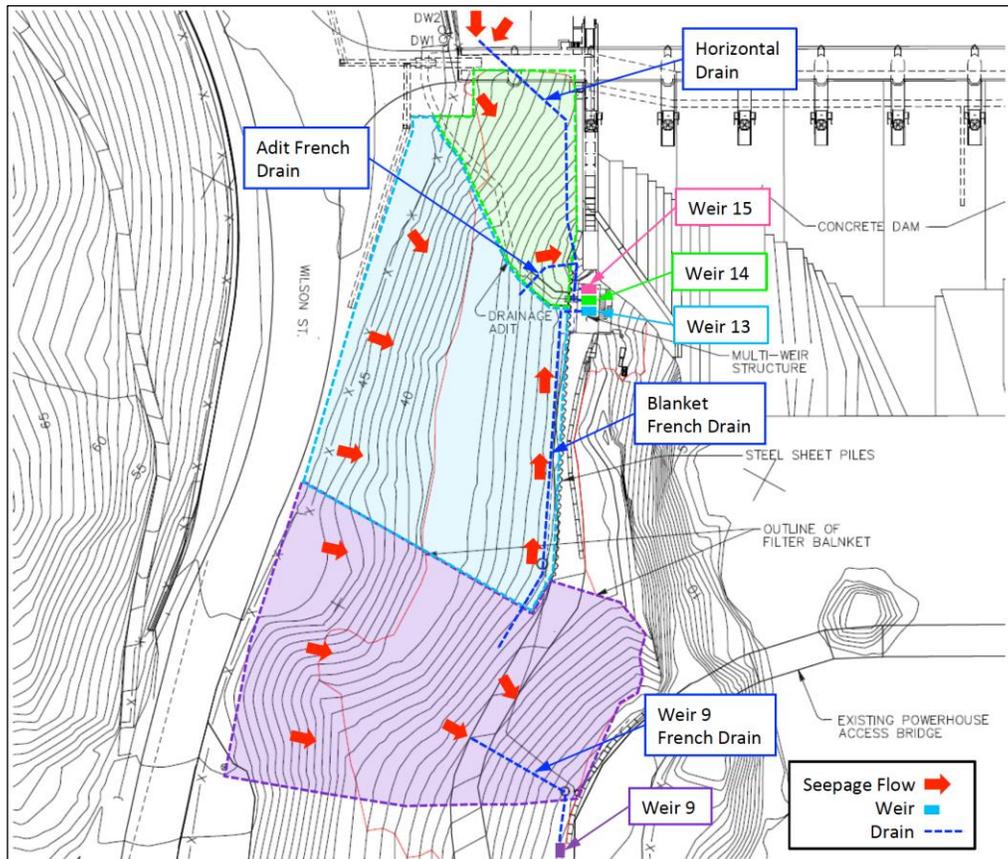
Figure 13: Seepage collection areas on the downstream right abutment

On the downstream slope, the upgrade consists of a two-zone filter blanket at a slope of 2 horizontal to 1 vertical, which is designed to keep the native soils from piping and allow seepage to be collected. The filter blanket consists of a 2.5 m wide zone of concrete sand, sized appropriately to prevent the migration of fines from

the Quadra Sand (but allow seepage), and a 2.5 m wide zone of fine rockfill to provide stability and protection of the filter. At the toe of the blanket an erosion barrier was installed in the Unit 3 and 4 soils above bedrock by the installation of a sheet pile wall. On the slope side of the sheet pile wall and below the blanket filter sand, a French drain was constructed consisting of slotted high-density polyethylene (HDPE) pipe, surrounded by drain gravel and filter sand. A separate French drain was constructed perpendicular to the portal of the drainage adit to collect potential seepage flows around the outside of the adit and from the area between the adit and the concrete dam pier. Both drains are connected to a weir house located about 32 m downstream of the dam, which was constructed on bedrock. Weir 13 (Blanket French Drain) and Weir 14 (Adit French Drain) currently monitor flows from the abutment, and Weir 15 will monitor flows from the horizontal drain once it has been completed. The location of the drains and the seepage collection areas on the downstream slope are shown in Figure 13.
