DAM SAFETY UPGRADE OF THE RUSKIN DAM RIGHT ABUTMENT

Nathan Sweeney, P. Eng., Senior Engineer, Generation Engineering, BC Hydro, Burnaby, BC, Canada
Li Yan, P. Eng., Engineering Team Lead, Generation Engineering, BC Hydro, Burnaby, BC, Canada

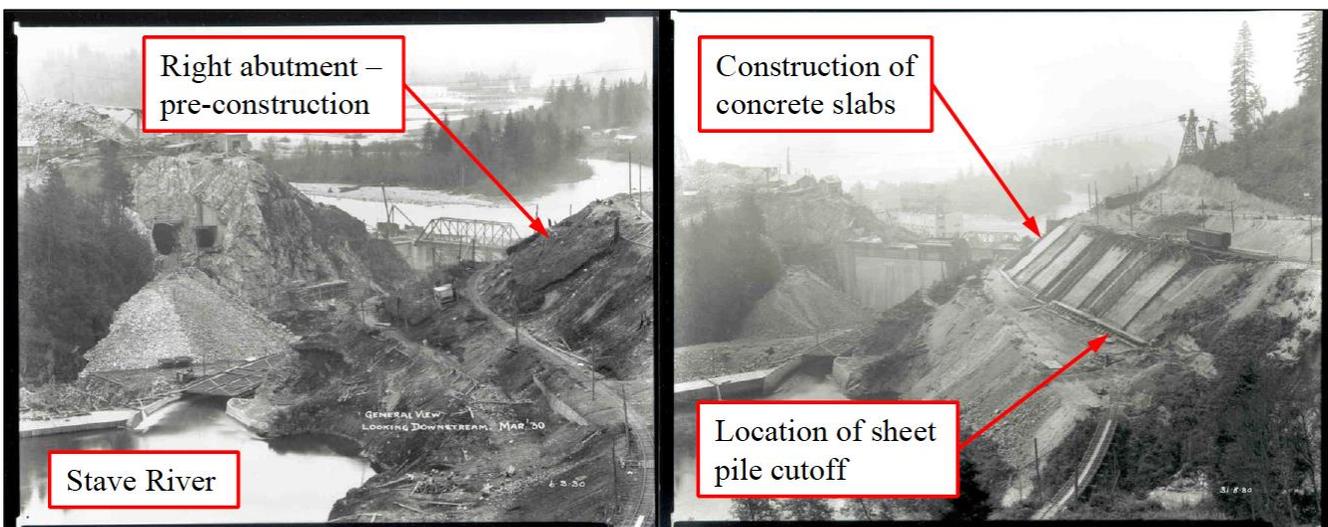
Figure 4: Right abutment prior to construction of original cut-off (left) and during construction of concrete slabs (right)

Performance issues occurred immediately in the right abutment during first filling of the reservoir in 1930, when sand-laden seepage flows began flowing from the finger drains into the gallery drain and exiting into the spillway (see Figure 3). Flows through the gallery drain reached a maximum of 566 l/min, and about 68 m³ of sand was measured over a period of 5 months, once the reservoir elevation had reached El. 42.6 m (near the normal maximum level). The constant loss of sand through the rockfill resulted in settlement of the concrete slabs in 1931, and an inclined shaft was constructed to inspect the underside of the slab. Cavities were backfilled with coarse gravel and grout was injected via pipes installed through holes in the face of the slabs in an attempt

to seal the voids in the rockfill. A number of remedial measures were attempted to stop the piping, including driving additional sheet piles and the placement of clay at the upstream end of the slabs, plugging the finger drains with sand and clay, and dumping clay at the joint between the gravity wall and core wall. In 1932, a 1.1 m wide by 1.5 m high adit was constructed to provide an alternate drainage path to the finger drains (see Figure 3). The concrete-lined-adit was connected to the rockfill via a gravel filled screen, which ensured that the rockfill remained dry above about El. 30 to 32 m. Flows were measured at the downstream end of the adit, and voids continued to be monitored beneath the slabs by soundings through the grout holes. Ground settlement and sinkholes continued to occur on the bank above the top of the concrete slabs.

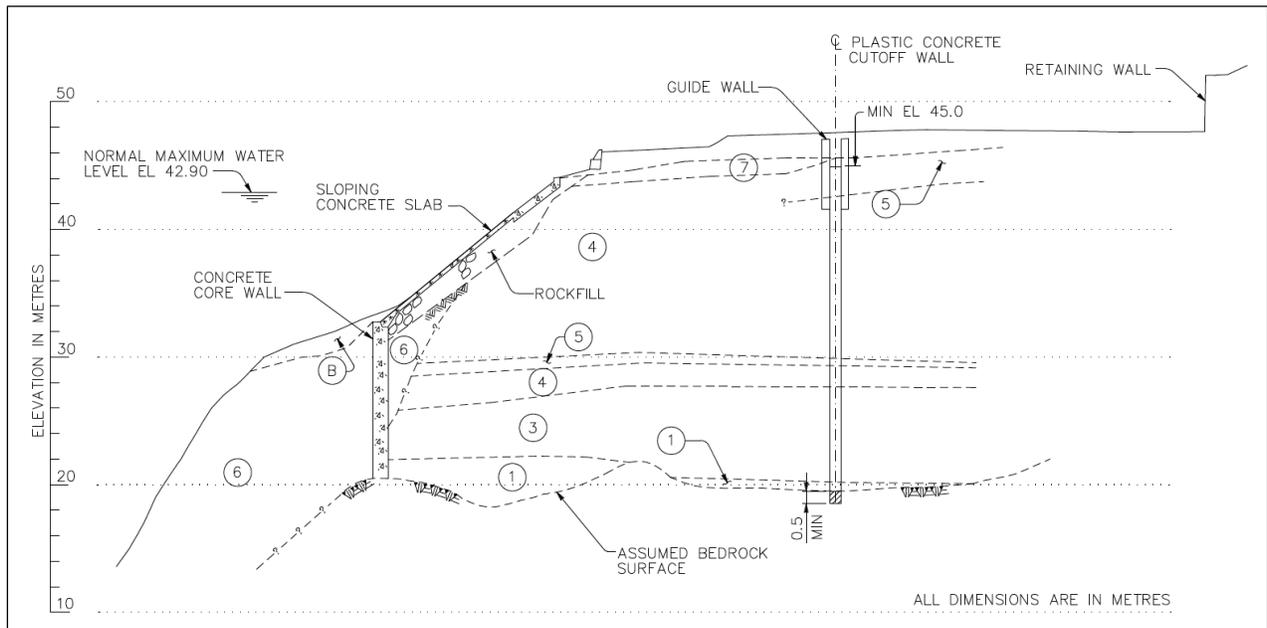
Figure 5: Configuration of foundation soil units for section through concrete core wall and slabs

Most of the dam safety issues at the right abutment are related to the presence of Quadra Sand (Unit 4). The sands, although dense, are highly susceptible to the seepage-caused migration of fine material, which can result in the formation of pipes and sinkholes or other forms of localized loosening. Quadra Sand is present on both the right and left abutments, but is most prevalent on the right abutment, where it ranges in thickness from about 15 to 20 m below the top of the dam (see Figure 6). The sand is also located on the hill above the dam with a variable thickness of up to about 20 m.
